**Chicora Research Contribution 542**

# **HISTORICAL SYNOPSIS, RECORDATION, AND ASSESSMENT OF GRAVESTONES IN THE TOGUS WEST NATIONAL CEMETERY, TOGUS, MAINE**

National Cemetery Administration  
U.S. Department of Veterans Affairs  
810 Vermont Avenue, NW  
Washington, DC 20420

March 2012

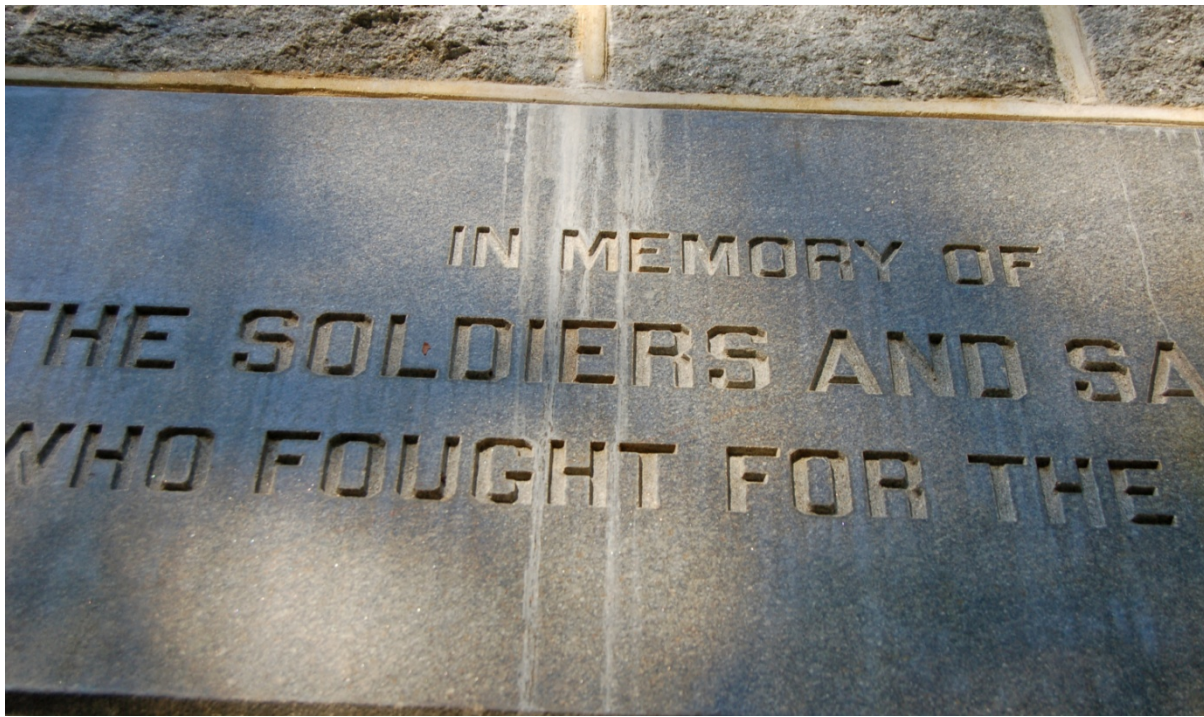
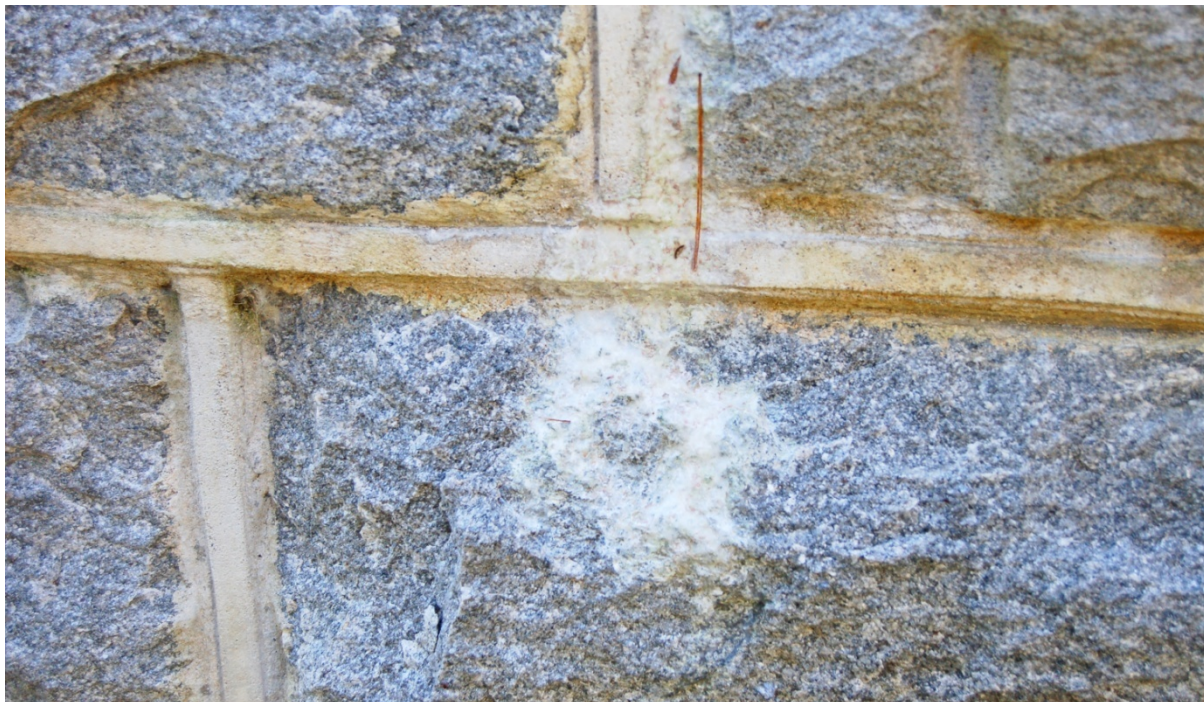
Figure 39. Examples of lime leaching. The upper photo shows staining on the polished plaques; the lower figure shows lime accumulations where water is actively removing lime from the mortar.

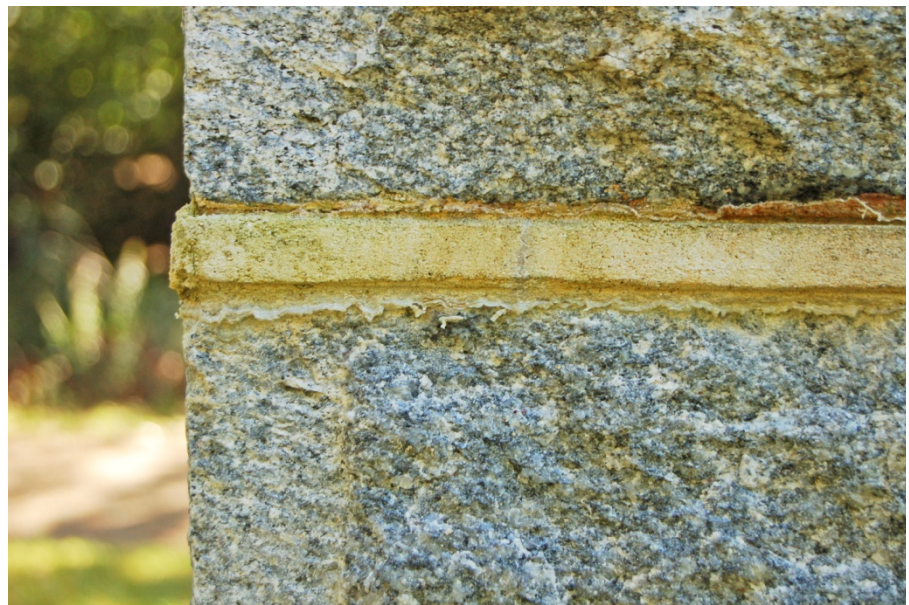
Figure 40. Salt deposits forming along the mortar joint.

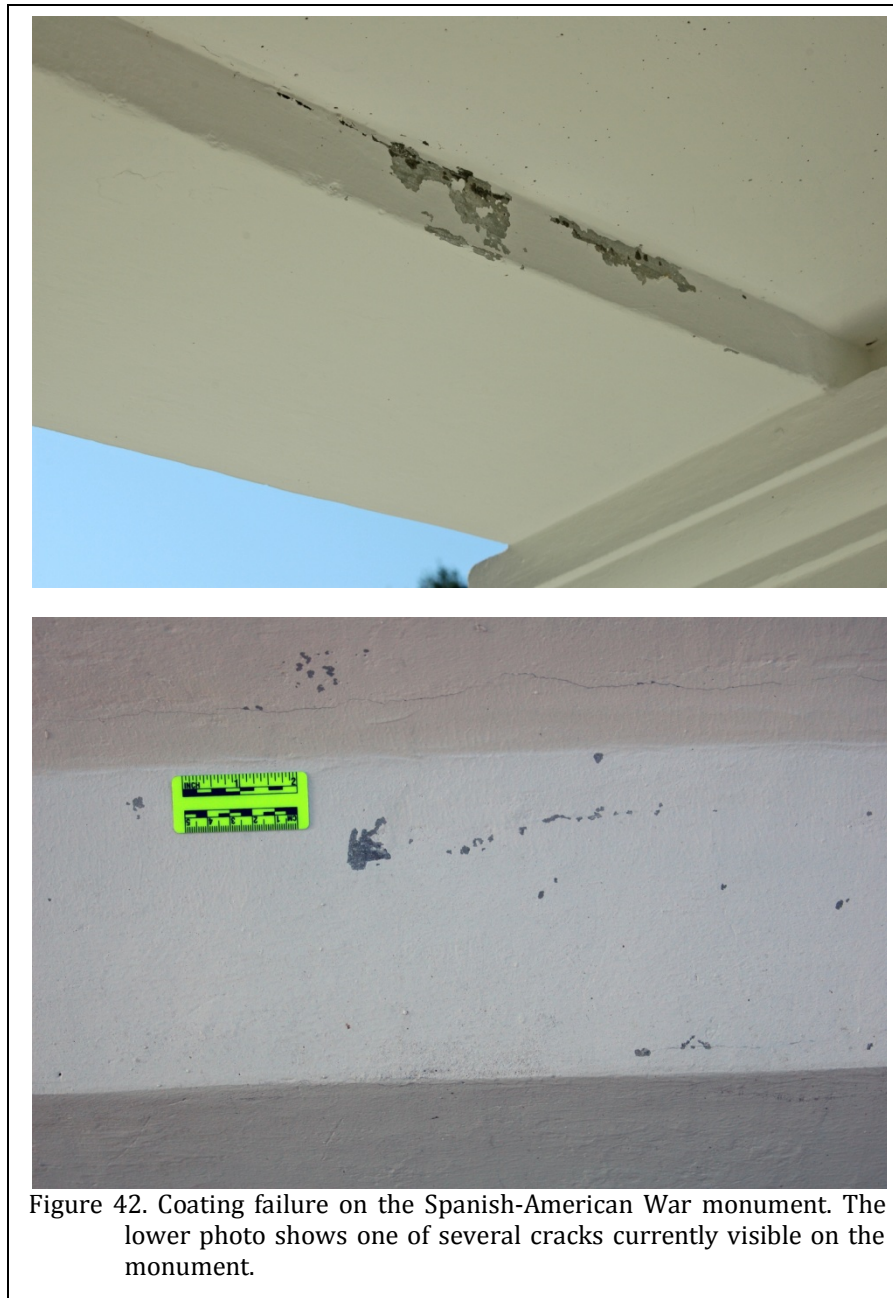
Figure 42. Coating failure on the Spanish-American War monument. The lower photo shows one of several cracks currently visible on the monument.

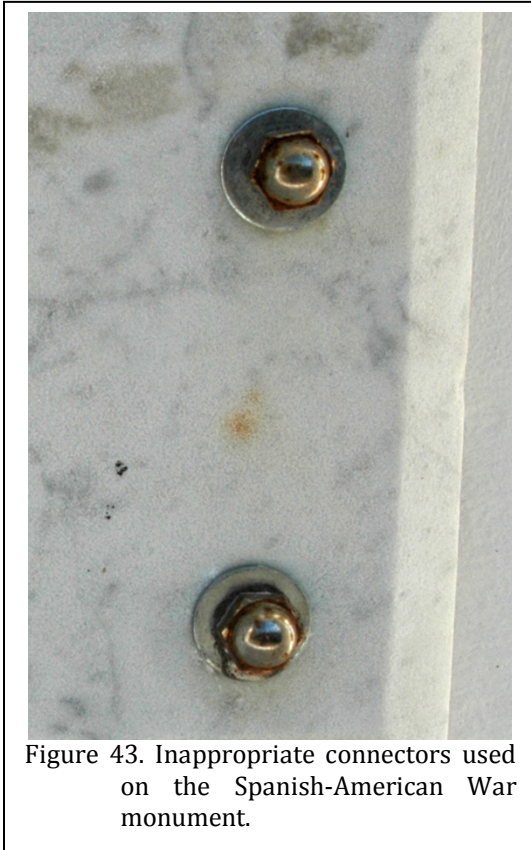
Figure 43. Inappropriate connectors used on the Spanish-American War monument.

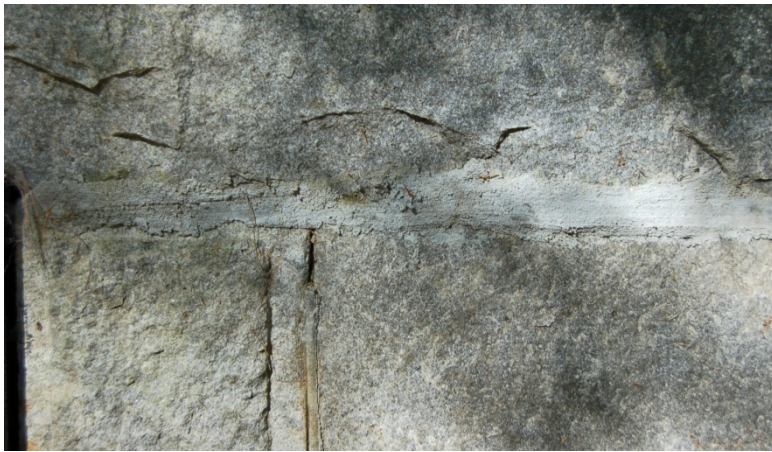
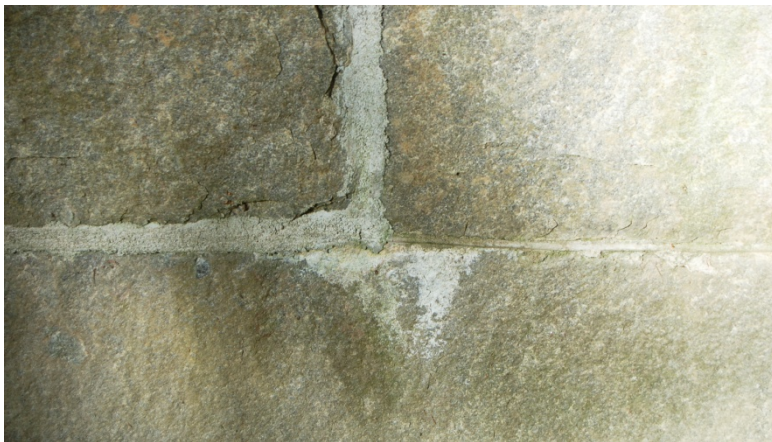
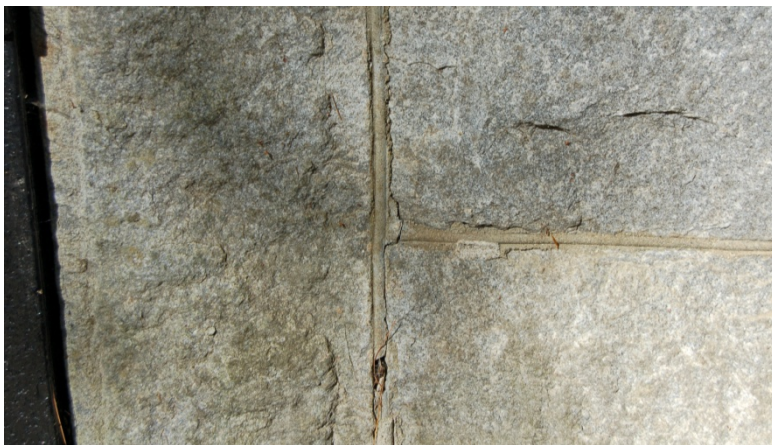
Figure 47. Inappropriate repairs on the vault. The upper two photos show inappropriate repointing. Note the sloppy application and failure to match the original mortar in color, texture, or joint finish. The lower photo shows original mortar joints with some cracked and missing mortar.

removal of the inappropriate recent repointing using Portland cement and appropriate pointing to match the original mortar in color, texture, and

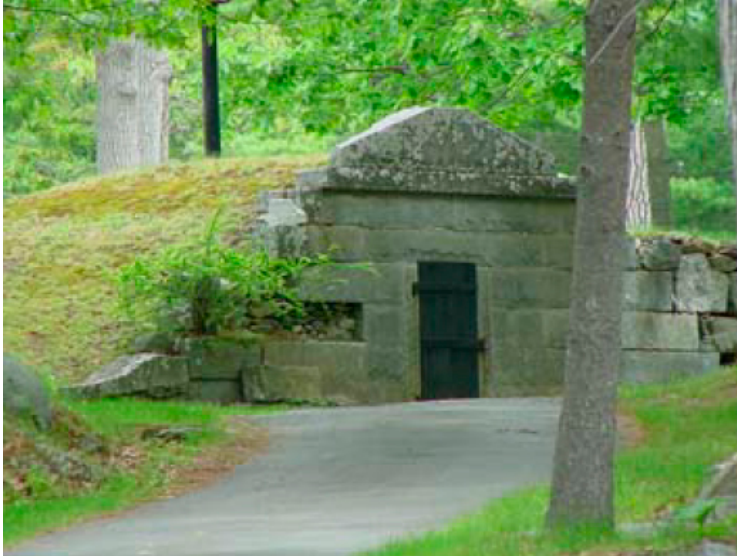
Figure 48. Vault about 2002 before recent repairs to the right façade. Compare to Figure 44.

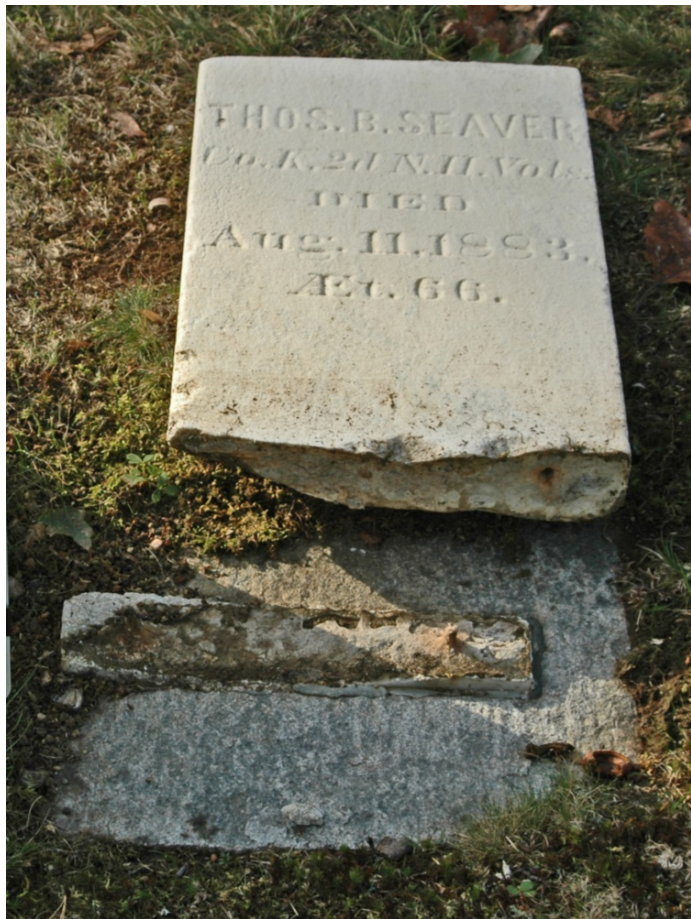
Figure 54. Example of a poor repair to an early stone (H-2-375)

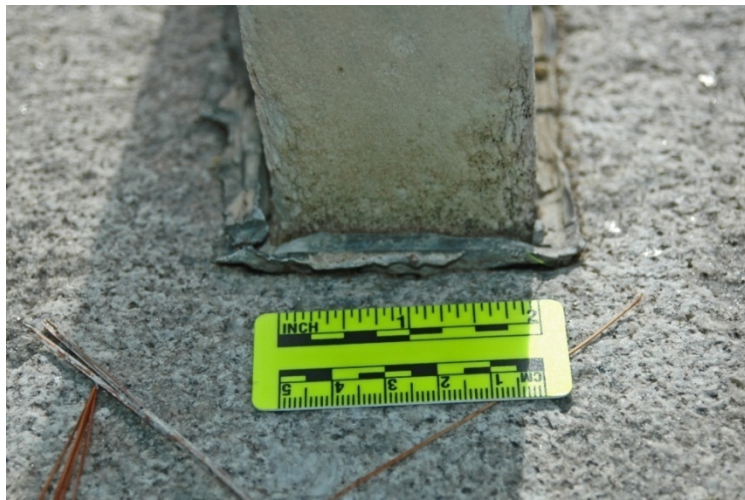
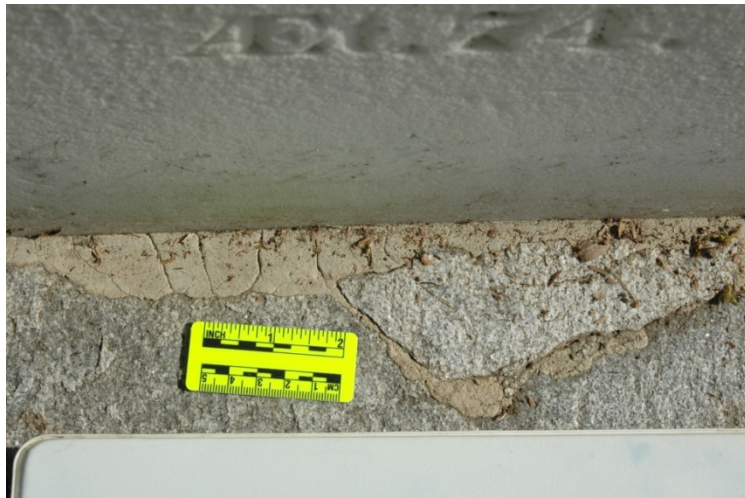
Figure 55. Lead used to set the original stones is shown in the upper photo. Note the gap that is allowing water to enter. The lower photo shows the use of a very hard grout to replace the lead. Not only is the grout too hard, but it has cracked. Two episodes of repair are visible.

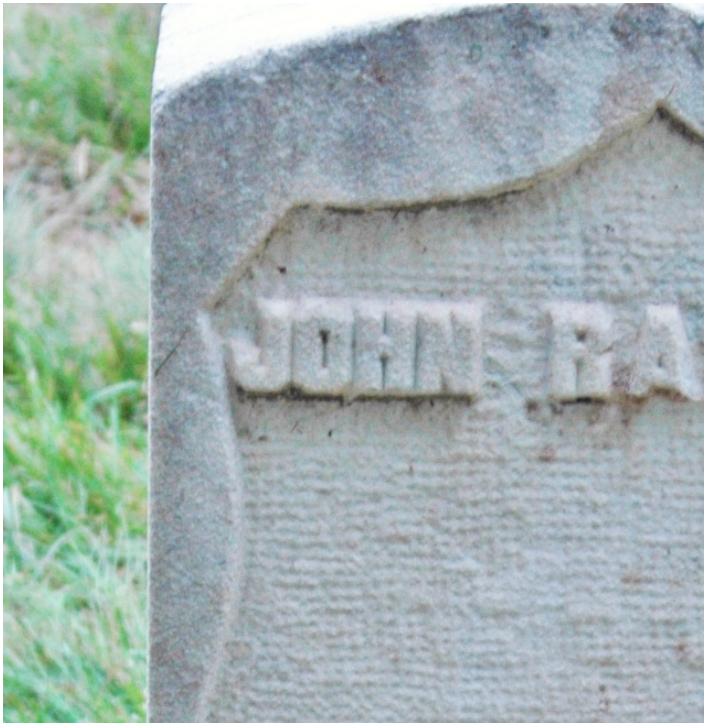
Figure 56. Close-up of a “Civil War” shield stone (L-2-4066) showing the use of a toothed chisel or solid tooth bush hammer to flatten and texture the shield. Work like this is costly to reproduce today, but is essential to maintain the appearance of the original stone.

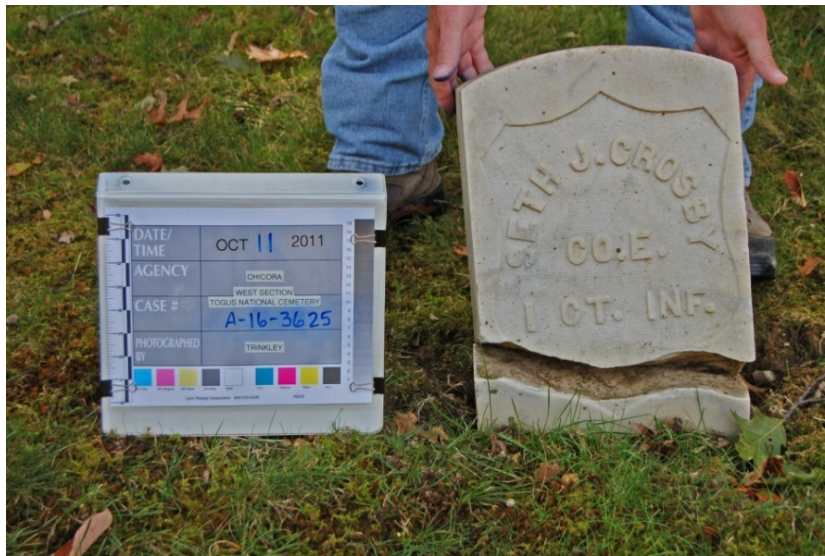
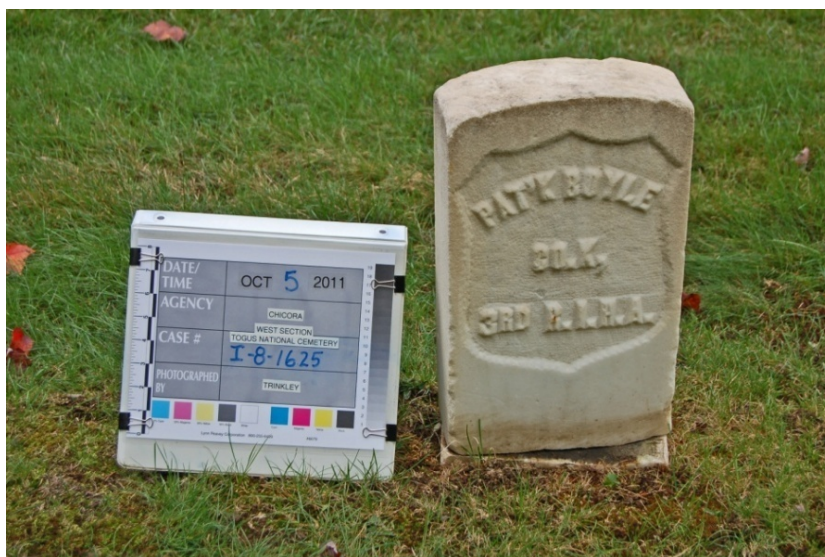
Figure 57. Examples of broken “Civil War” shield stones. These should be repaired by a conservator, not replaced.

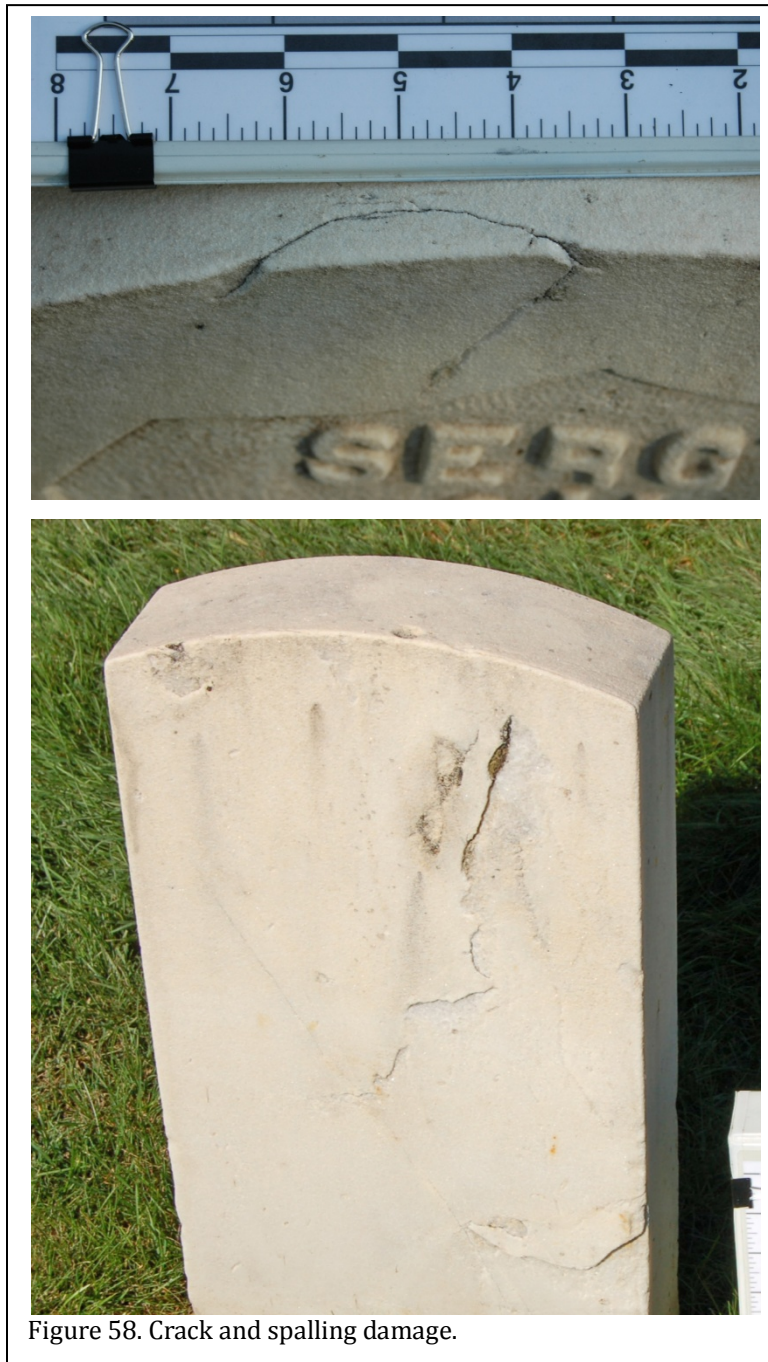
Figure 58. Crack and spalling damage.

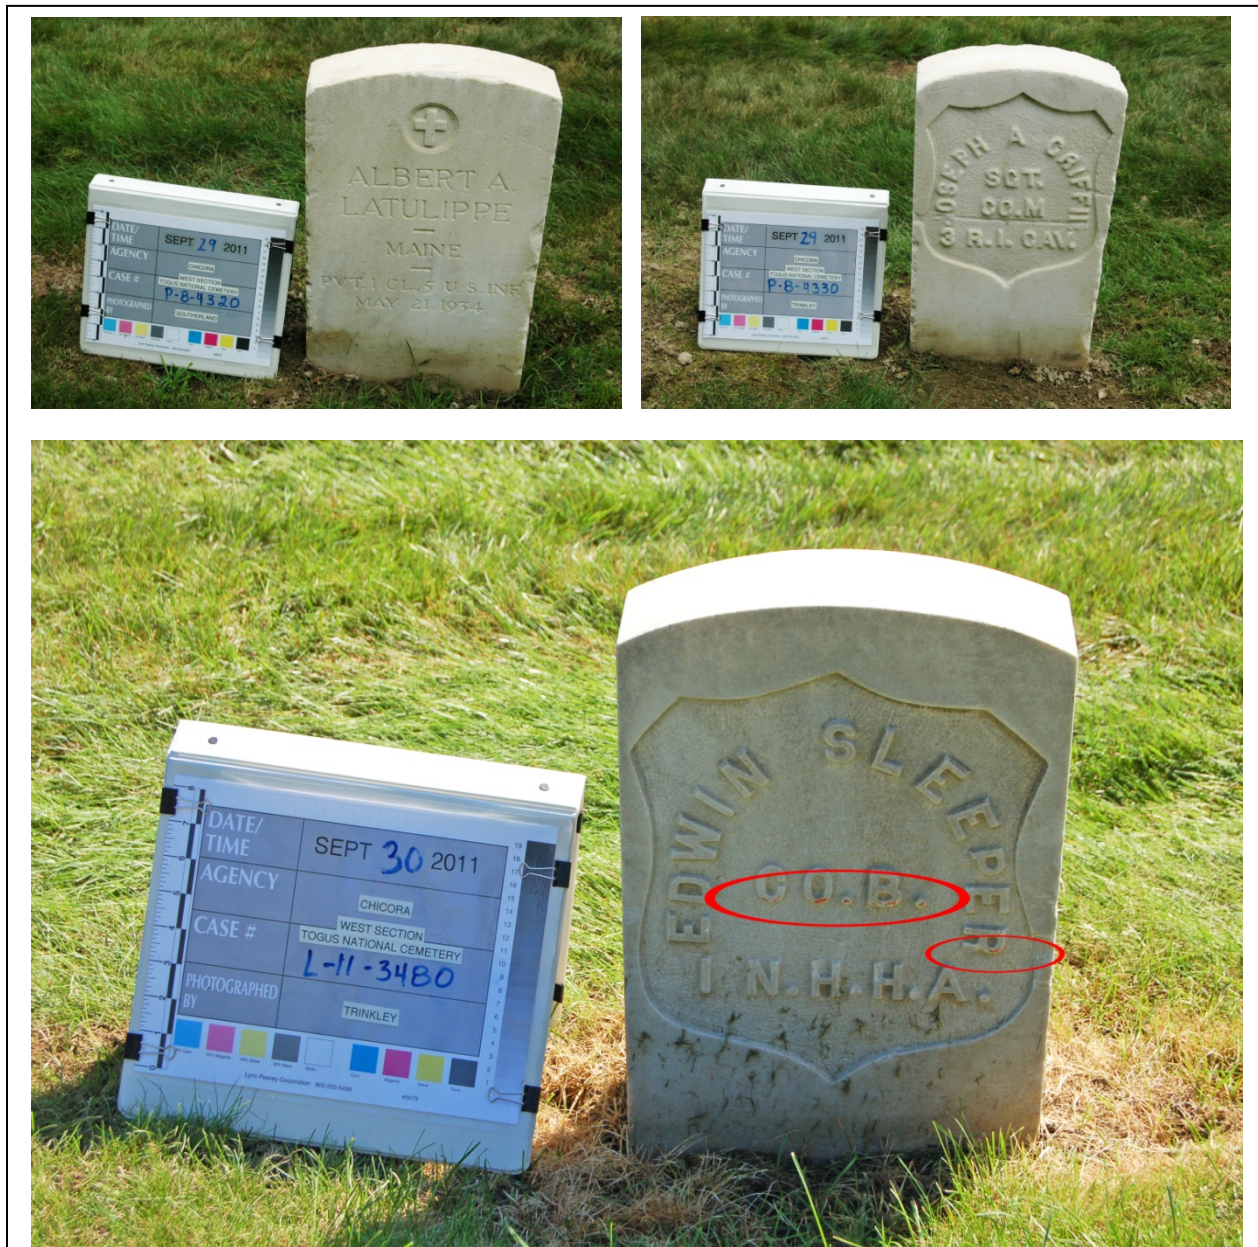
Figure 61. Examples of mower damage at West Cemetery. Upper left photo shows a stone with a wide variety of chips and edge damage resulting from mower impacts. Upper right photo shows a stone that has been scraped by a riding mower causing a linear gouge across the face of the stone, as well as the loss of several letters. Also present is edge damage from more “routine” bumps and impacts. The lower photo shows orange paint transfer from a mower.

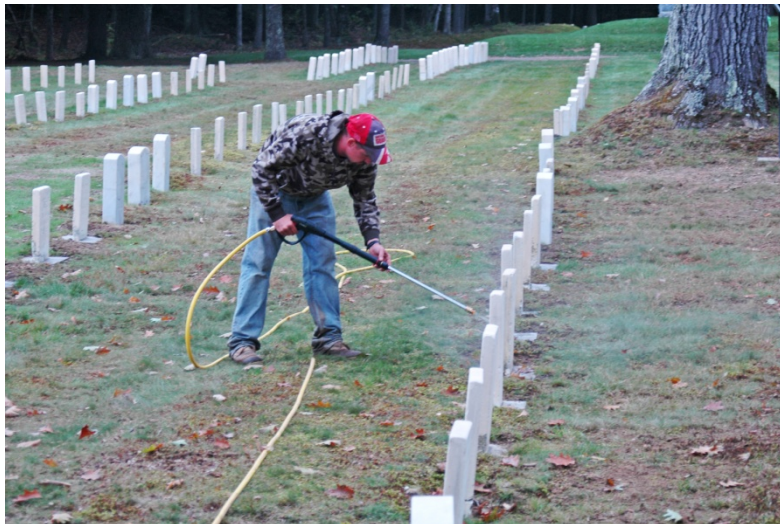
Figure 62. Use of a power washer on the oldest stones in the West Cemetery. There is no “safe” pressure above 90 psi. The gun is being held too close to the stone, even with the use of a fan tip.

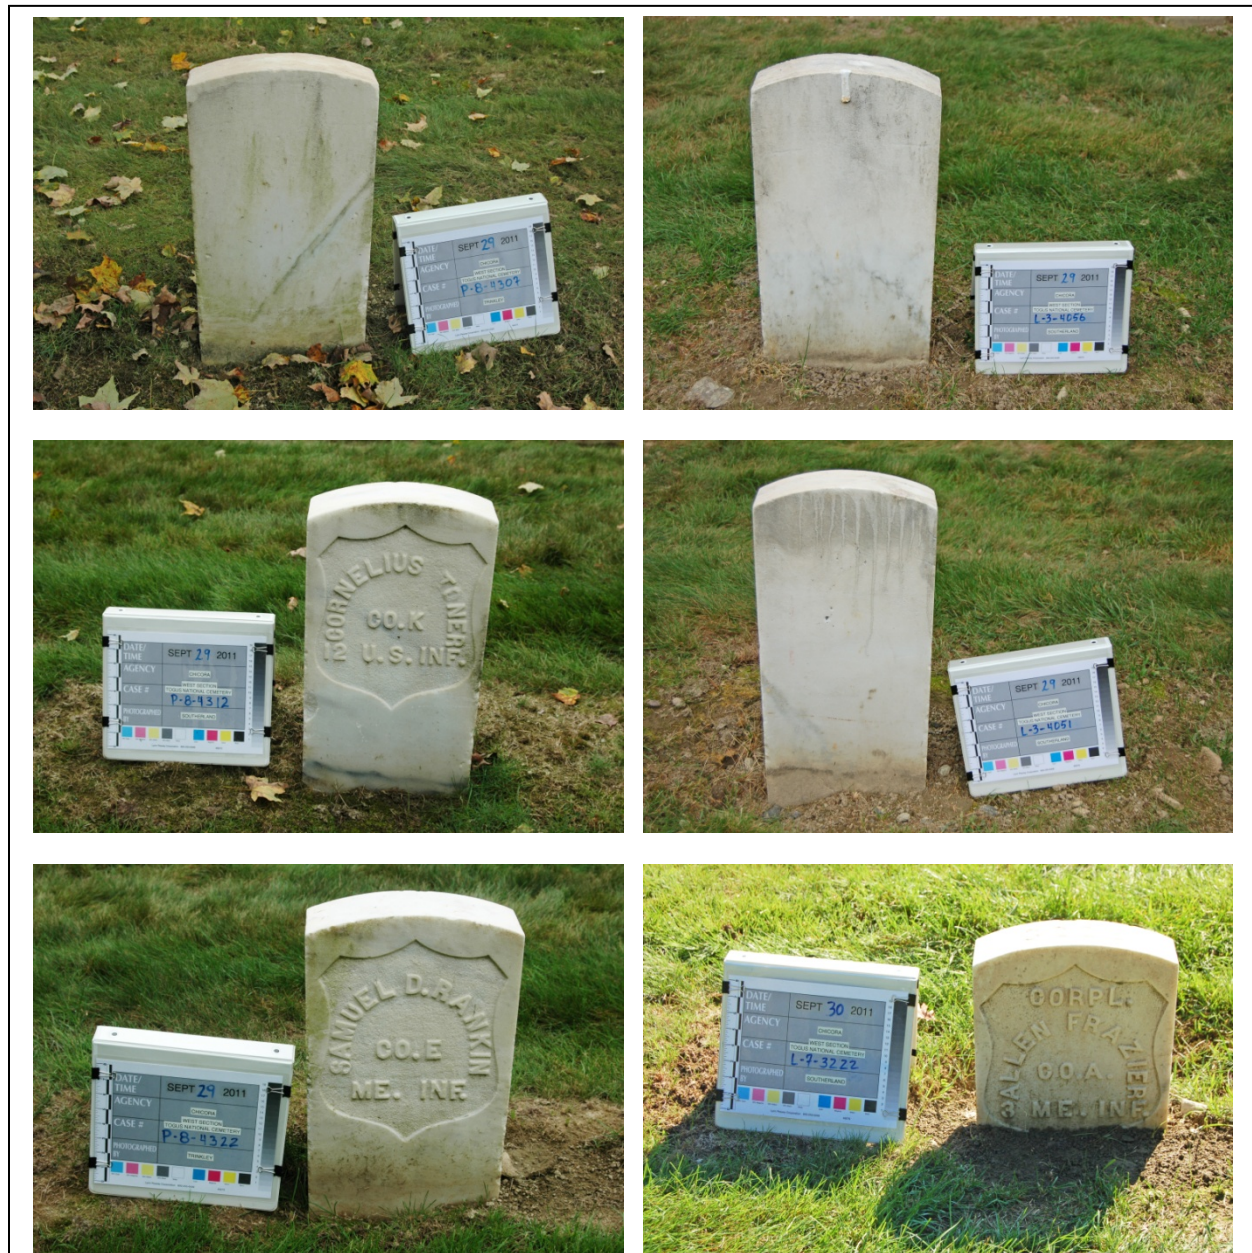
Figure 63. Examples of soiled stones at West Cemetery. Upper left shows algae. This can be readily removed by D/2 and likely will not return for 3-6 months. Upper right shows a bird dropping; while readily removed there is no control over this sort of soiling. Middle left shows dark stain that may be atmospheric soiling, which results from atmospheric pollutants. The middle right photo shows how this staining is partially removed by acid rain. Lower left photo shows grass adhering to the stone after the use of a nylon trimmer. The stone also exhibits algae growth. The lower right photo shows soil splash-back. With no grass growing after a "bump and run," this sort of soiling will occur after every rain.

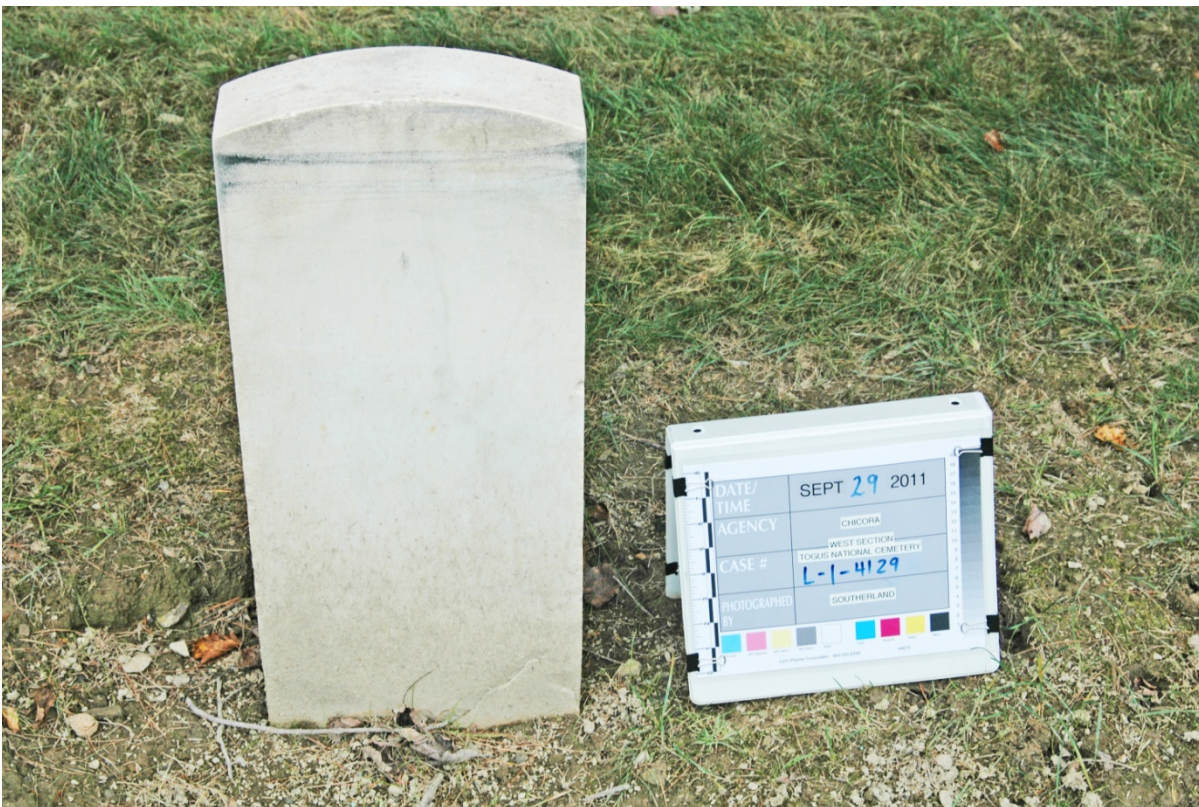
Figure 64. Black rubber stain on the reverse of a reset stone. Note also that the hole was not adequately refilled, creating a dished area that holds water and creates additional splash back and erosion.

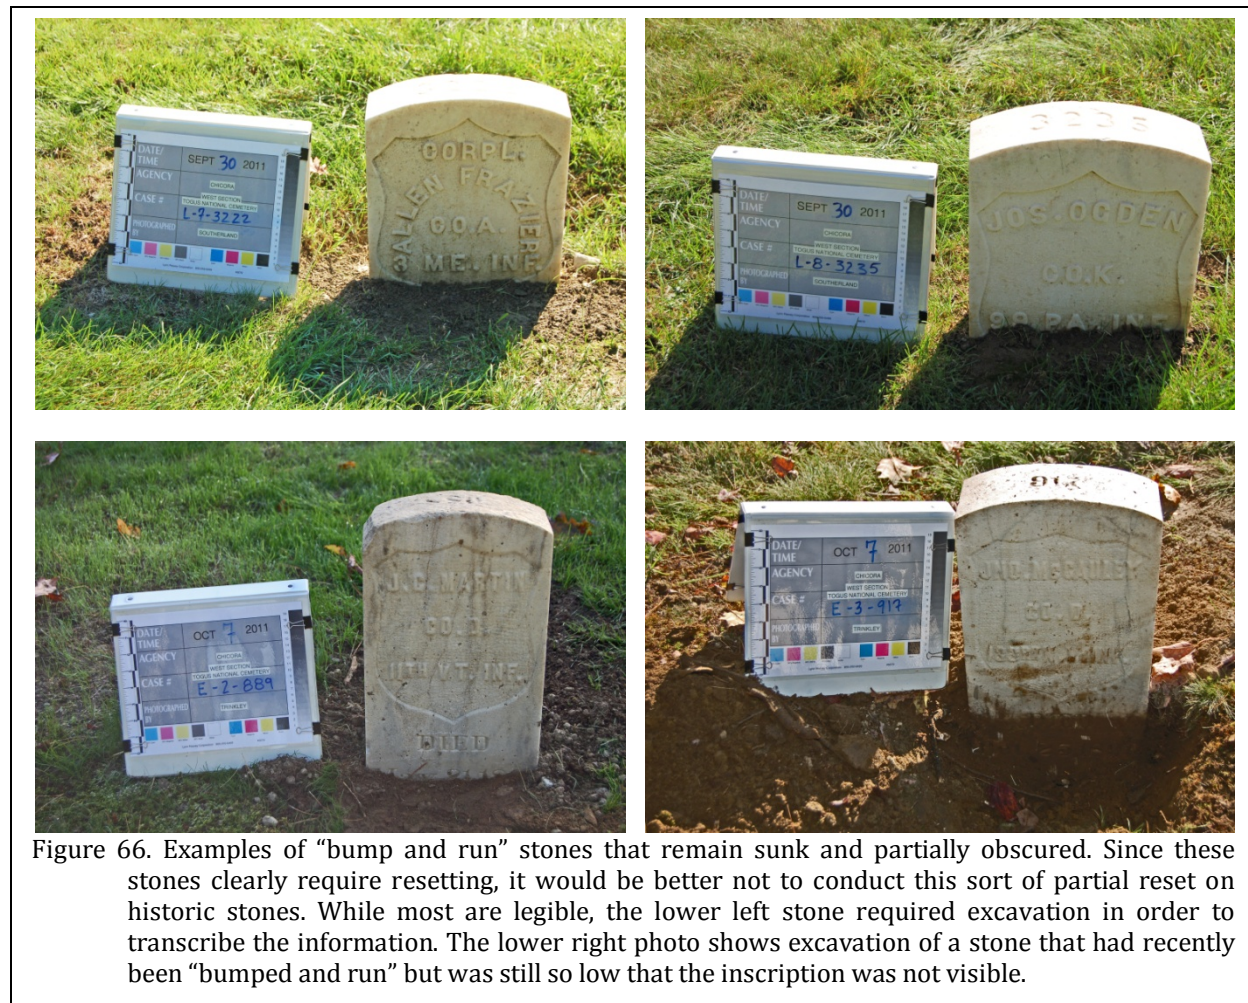
Figure 66. Examples of “bump and run” stones that remain sunk and partially obscured. Since these stones clearly require resetting, it would be better not to conduct this sort of partial reset on historic stones. While most are legible, the lower left stone required excavation in order to transcribe the information. The lower right photo shows excavation of a stone that had recently been “bumped and run” but was still so low that the inscription was not visible.
